COLUMBIA

ACCIDENT INVESTIGATION BOARD

REPORT VOLUME I
AUGUST 2003

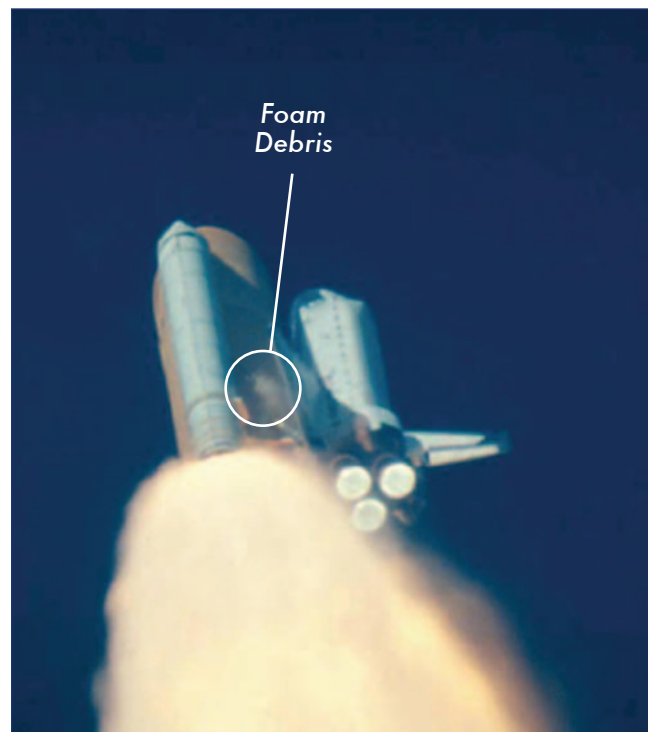
Figure 2.3-2. A shower of foam debris after the impact on *Columbia's* left wing. The event was not observed in real time.

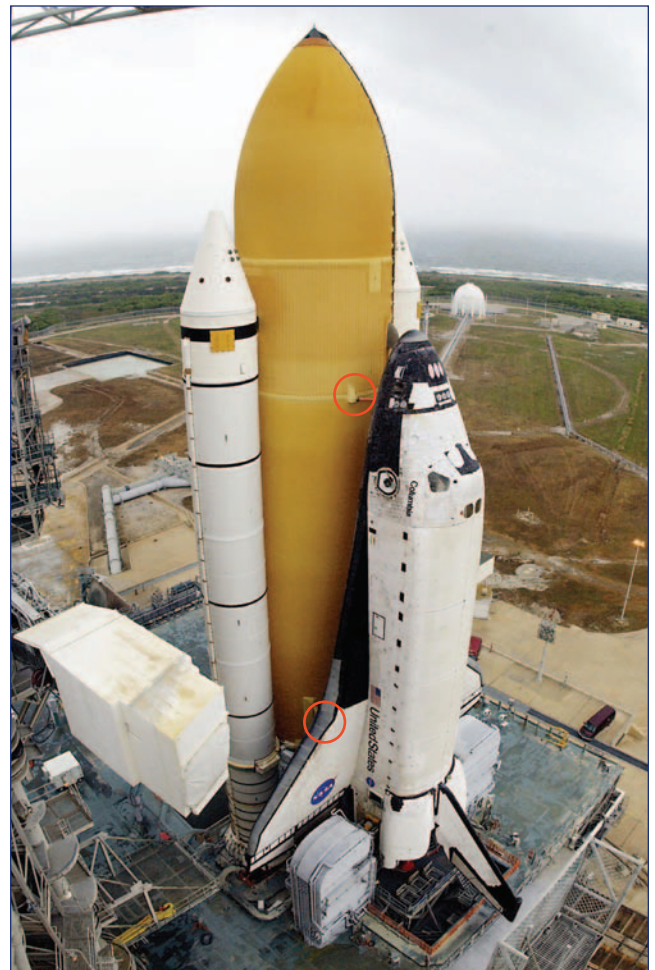
Figure 3.1-1. Columbia sitting at Launch Complex 39-A. The upper circle shows the left bipod (-Y) ramp on the forward attach point, while the lower circle is around RCC panel 8-left.

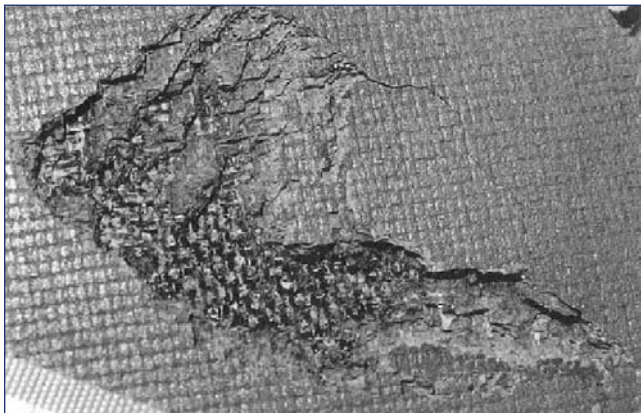
Figure 3.3-2. Damage on the outer surface of RCC panel 10-right from *Atlantis* after STS-45.

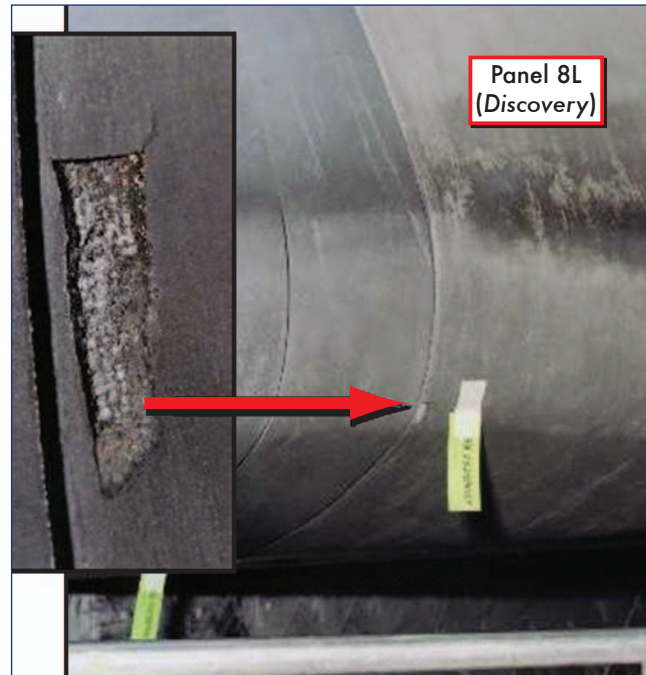
Figure 3.3-5. RCC panel 8-left from *Discovery* had to be scrapped after STS-103 because of the damage shown here.

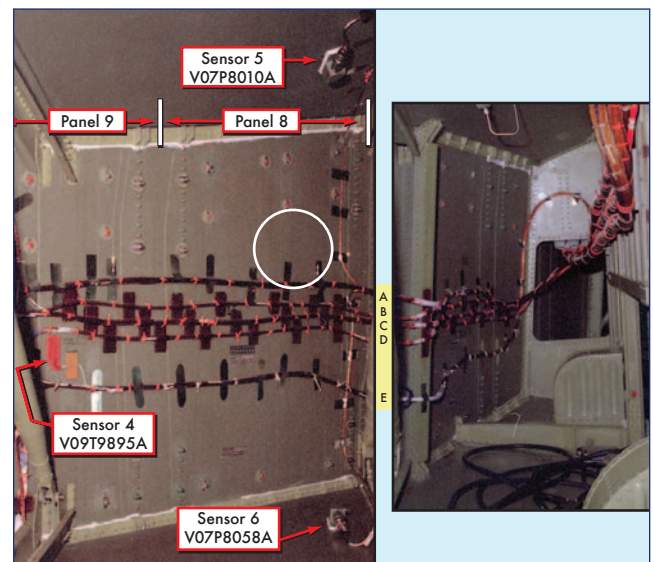
Figure 3.6-8. The left photo above shows the wiring runs on the backside of the wing leading edge behind RCC panel 8 – the circle marks the most likely area where the burn through of the wing leading edge spar initially occurred at EI+487 seconds. The right photo shows the wire bundles as they continue forward behind RCC panels 7 and 6. The major cable bundles in the upper right of the right photo carried the majority of the sensor data inside the wing. As these bundles were burned, controllers on the ground began seeing off-nominal sensor indications.

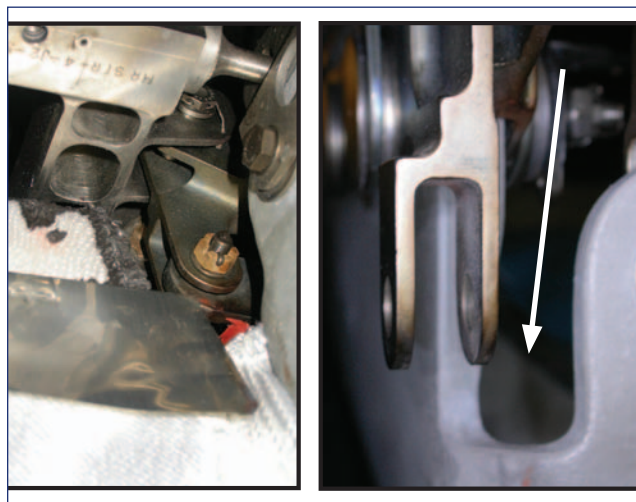
Figure 3.7-2. Each RCC panel has a U-shaped slot (see arrow) in the back of the panel. Once superheated air entered the breach in RCC panel 8, some of that superheated air went through this slot and caused substantial damage to the Thermal Protection System tiles behind this area.

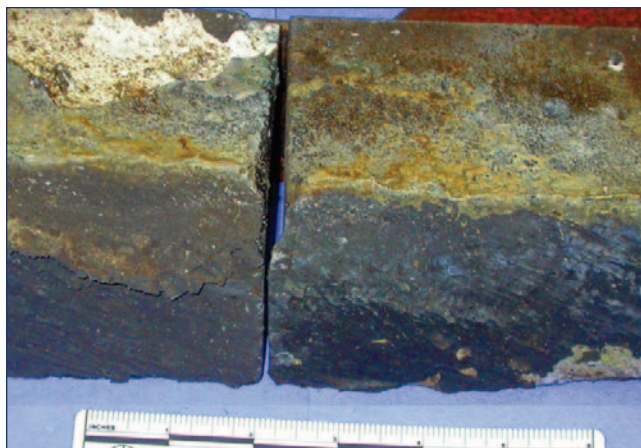
Figure 3.7-3. Superheated airflow caused erosion in tiles around the RCC panel 8 and 9 interface. The tiles shown are from behind the area where the superheated air exited the slot in Figure 3.7-2. These tiles showed much greater thermal damage than other tiles in this area and chemical analysis showed the presence of metals only found in wing leading edge components.

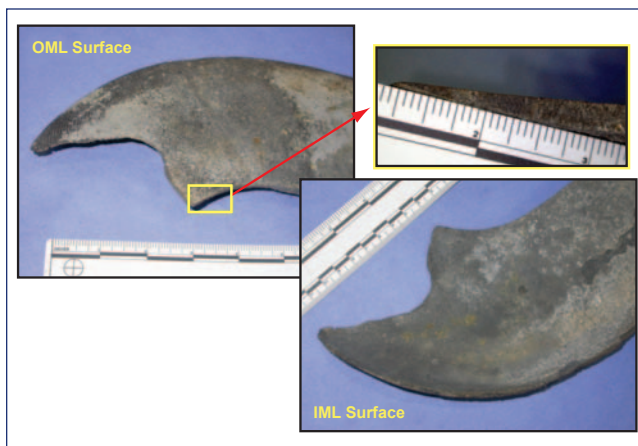
Figure 3.7-4. The outboard rib of panel 8 and the inboard rib of panel 9 showed signs of extreme heating and erosion. RCC erosion of this magnitude was not observed in any other location on the Orbiter.

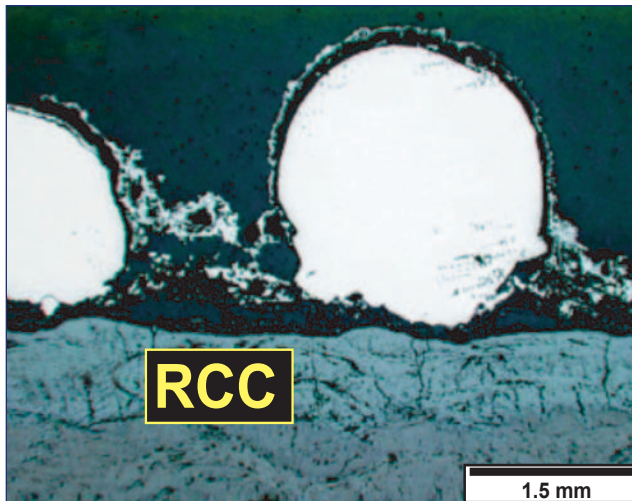
Figure 3.7-8. Spheroids of Inconel 718 and Cerachrome were deposited directly on the surface of RCC panel 8-left. This slag deposit pattern was not seen on any other RCC panels.

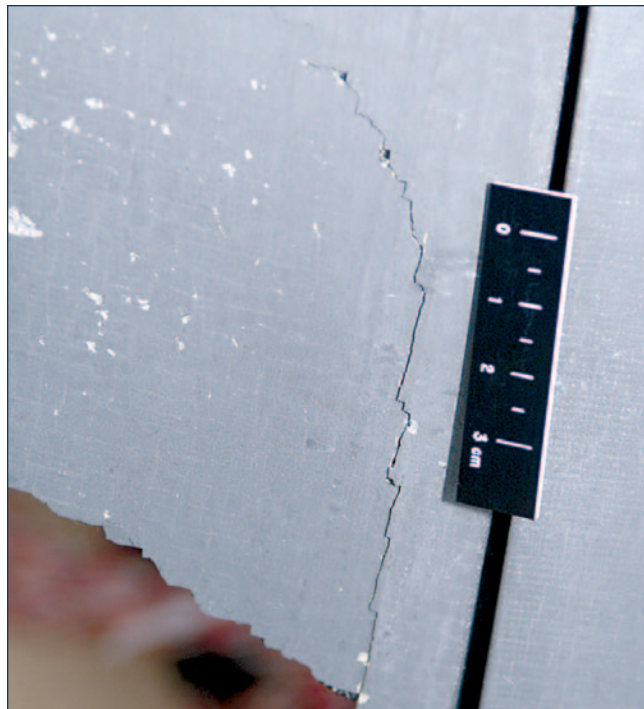
Figure 3.8-10. Numerous cracks were also noted in RCC Panel 8.

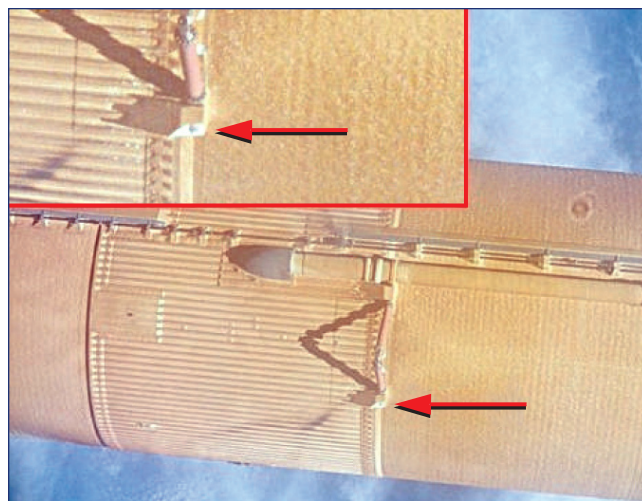
Figure 6.1-3. Only three months before the final launch of Columbia, the bipod ramp foam had come off during STS-112.
