COLUMBIA

ACCIDENT INVESTIGATION BOARD

REPORT VOLUME I
AUGUST 2003

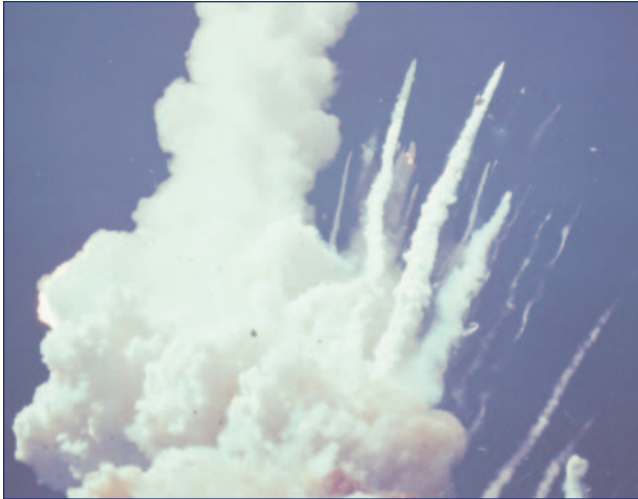
Figure 1.5-1. the Space Shuttle Challenger was lost during ascent on January 28, 1986, when an O-ring and seal in the left Solid Rocket Booster failed.

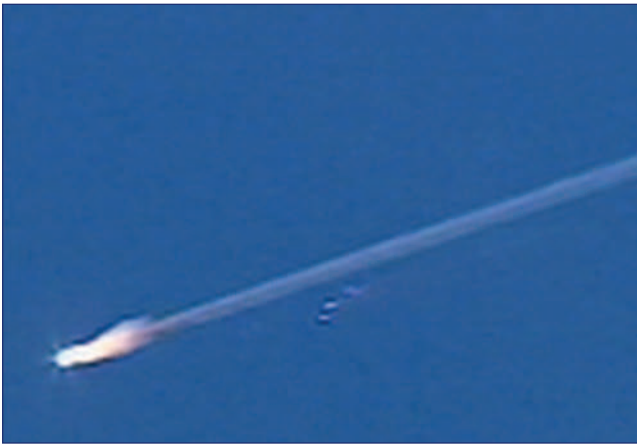
The Orbiter has a large glowing field surrounding it in this view taken from Mesquite, Texas, looking south.

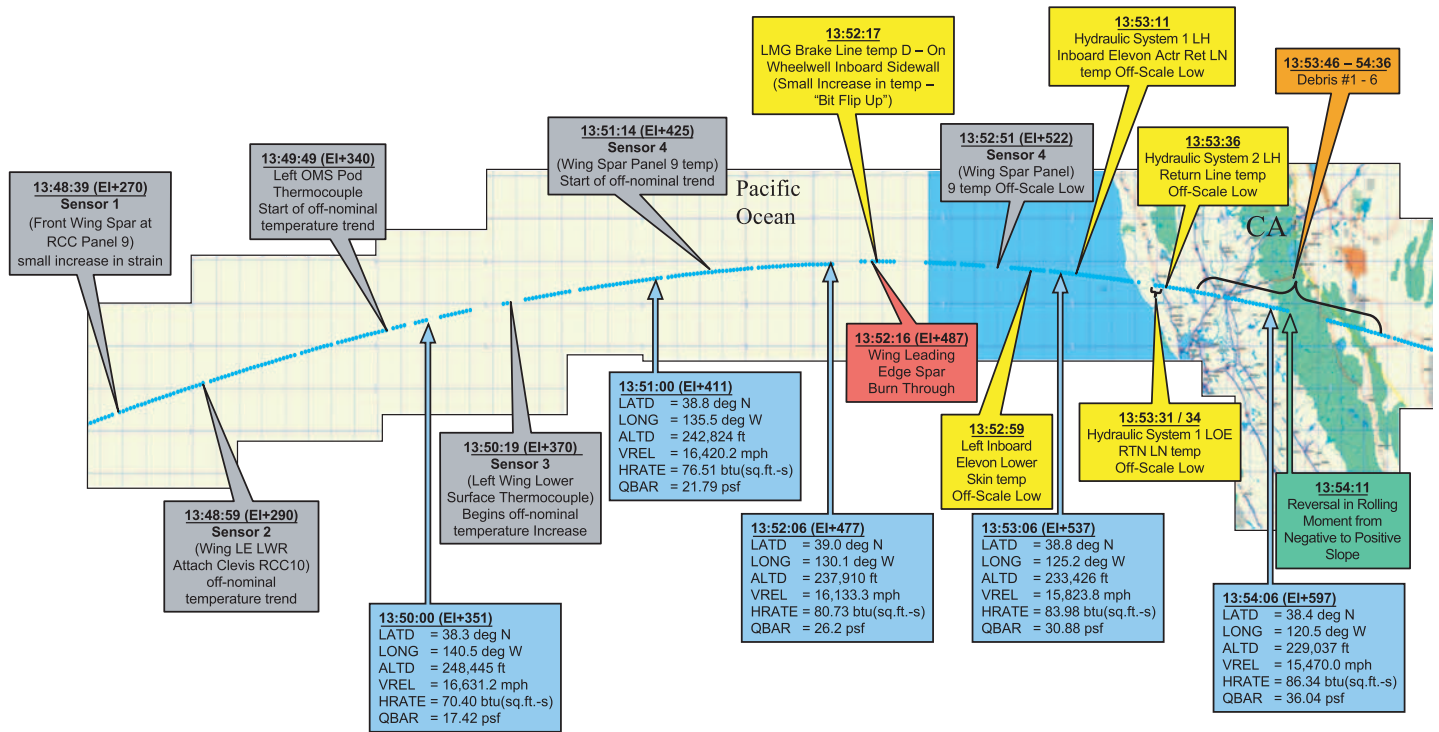
At 8:48:39 a.m. (EI+270), a sensor on the left wing leading edge spar showed strains higher than those seen on previous *Columbia* re-entries. This was recorded only on the Modular Auxiliary Data System, and was not telemetered to ground controllers or displayed to the crew (see Figure 2.6-1).

Figure 2.6-1. This simplified timeline shows the re-entry path of Columbia on February 1, 2003. The information presented here is a composite of sensor data telemetered to the ground combined with data from the Modular Auxiliary Data System recorder recovered after the accident. Note that the first off-nominal reading was a small increase in a strain gauge at the front wing spar behind RCC panel 9-left. The chart is color-coded: blue boxes contain position, attitude, and velocity information; orange boxes indicate when debris was shed from the Orbiter; green boxes are significant aerodynamic control events; gray boxes contain sensor information from the Modular Auxiliary Data System; and yellow boxes contain telemetered sensor information. The red boxes indicate other significant events.

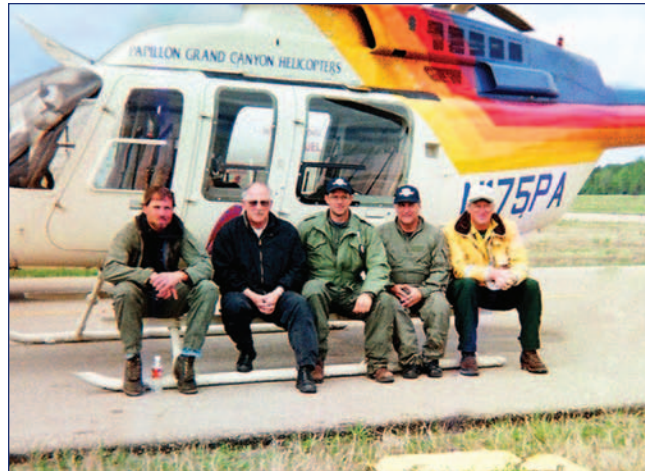
Figure 2.7-3. Tragically, a helicopter crash during the debris search claimed the lives of Jules "Buzz" Mier (in black coat) and Charles Krenek (yellow coat).

ty of the East Texas vegetation, the small sizes of the debris, and the inability of sensors to differentiate Orbiter material from other objects, these devices proved of little value. As a result, the detection work fell to spotter teams who visually scanned the terrain. Air search coordinators apportioned grids to allow a 50 percent probability of detection for a one-foot-square object. Civil Air Patrol volunteers and others in powered parachutes, a type of ultralight aircraft, also participated in the search, but were less successful than helicopter and fixed-wing air crews in retrieving debris. During the air search, a Bell 407 helicopter crashed in Angelina National Forest in San Augustine County after a mechanical failure. The accident took the lives of Jules F. "Buzz" Mier Jr., a contract pilot, and Charles Krenek, a Texas Forest Service employee, and injured three others (see Figure 2.7-3).

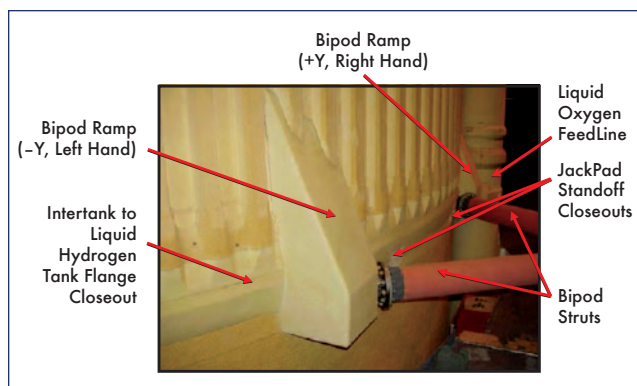
The physical cause of the loss of *Columbia* and its crew was a breach in the Thermal Protection System on the leading edge of the left wing. The breach was initiated by a piece of insulating foam that separated from the left bipod ramp of the External Tank and struck the wing in the vicinity of the lower half of Reinforced Carbon-Carbon panel 8 at 81.9 seconds after launch. During re-entry, this breach in the Thermal

Figure 3.2-2. The exterior of the left bipod attachment area showing the foam ramp that came off during the ascent of STS-107.

A combination of factors, rather than a single factor, led to the loss of the left bipod foam ramp during the ascent of STS-107. NASA personnel believe that testing conducted during the investigation, including the dissection of as-built hardware and testing of simulated defects, showed conclusively that pre-existing defects in the foam were a major factor, and in briefings to the Board, these were cited as a necessary condition for foam loss. However, analysis indicated that pre-existing defects alone were not responsible for foam loss.

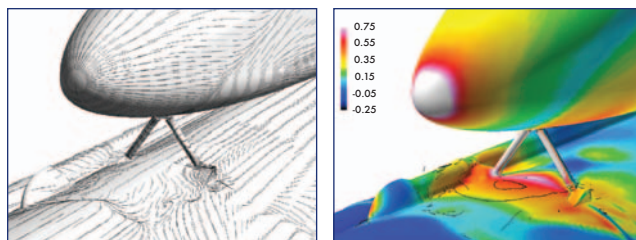
Figure 3.2-5. Computational Fluid Dynamics was used to understand the complex flow fields and pressure coefficients around bipod strut. The flight conditions shown here approximate those present when the left bipod foam ramp was lost from External Tank 93 at Mach 2.46 at a 2.08-degree angle of attack.

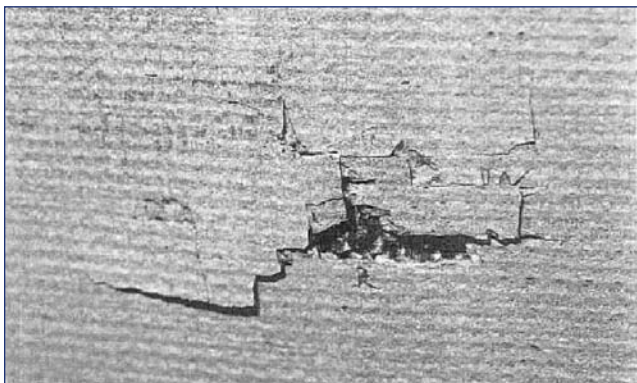
RCC components have been struck by objects throughout their operational life, but none of these components has been completely penetrated. A sampling of 21 post-flight reports noted 43 hypervelocity impacts, the largest being 0.2 inch. The most significant low-velocity impact was to *Atlantis*' panel 10-right during STS-45 in March and April 1992. The damaged area was 1.9 inches by 1.6 inches on the exterior surface and 0.5 inches by 0.1 inches in the interior surface. The substrate was exposed and oxidized, and the panel was scrapped. Analysis concluded that the damage was caused by a strike by a man-made object, possibly during ascent. Figures 3.3-2 and 3.3-3 show the damage to the outer and inner surfaces, respectively.

Figure 3.3-3. Damage on the inner surface of RCC panel 10-right from *Atlantis* after STS-45.

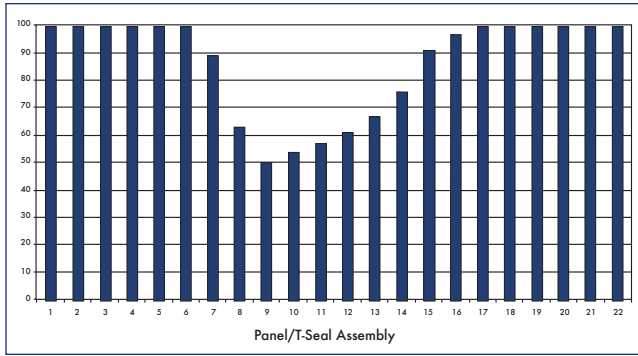
For the first five missions of *Columbia*, the RCC components were not coated with Type A sealant, and had shorter mission service lives than the RCC components on the other Orbiters. (*Columbia*'s panel 9 has the shortest mission service life of 50 flights as shown in Figure 3.3-4.) The predicted life for panel/T-seals 7 through 16 range from 54 to 97 flights.⁷

Figure 3.3-4. The expected mission life for each of the wing leading edge RCC panels on Columbia. Note that panel 9 has the shortest life expectancy.

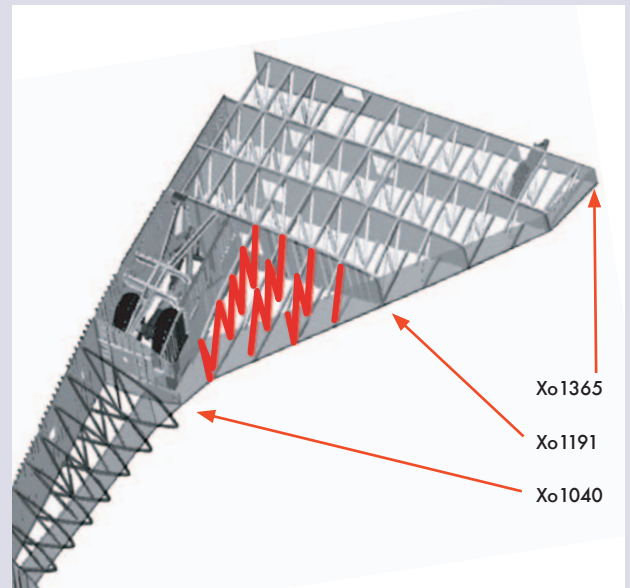
The Wing Leading Edge Structural System on Columbia.

The major internal support structures in the mid-wing are constructed from aluminum alloy. Since aluminum melts at 1,200 degrees Fahrenheit, it is likely these truss tubes in the mid-wing were destroyed and wing structural integrity was lost.

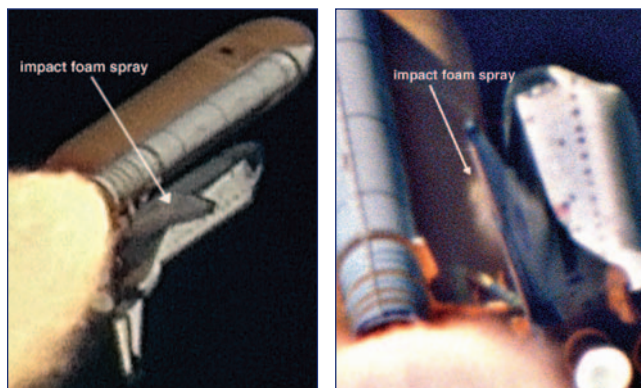
Figure 3.4-1 (color enhanced and "de-blurred" by Lockheed Martin Gaithersburg) and Figure 3.4-2 (processed by the National Imagery and Mapping Agency) are samples of the type of visual data used to establish the time of the impact (81.9 seconds), the altitude at which it occurred (65,860 feet), and the object's relative velocity at impact (about 545 mph relative to the Orbiter).

A 35-mm film camera, E212, which recorded the foam strike from 17 miles away, and video camera E208, which recorded it from 26 miles away, provided the best of the available evidence. Analysis of this visual evidence (see Figures 3.4-1 and 3.4-2) along with computer-aided design analysis, refined the potential impact area to less than 20 square feet in RCC panels 6 through 9 (see Figure 3.4-3), including a portion of the corresponding carrier panels and adjacent tiles. The investigation image analysis team found no conclusive visual evidence of post-impact debris flowing over the top of the wing.

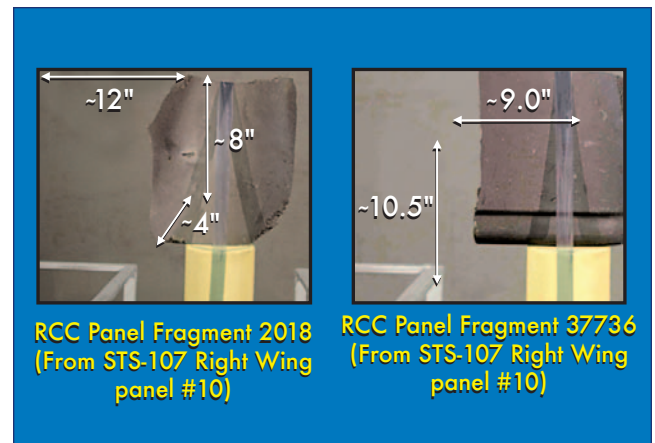
Figure 3.5-1. These representative RCC acreage pieces matched the radar cross-section of the Flight Day 2 object.

In the Advanced Compact Range at the Air Force Research Laboratory in Dayton, Ohio, analysts tested 31 materials from the Orbiter's exterior and payload bay. Additional supercomputer radar cross-section predictions were made for Reinforced Carbon-Carbon T-seals. After exhaustive radar cross-section analysis and testing, coupled with ballistic analysis of the object's orbital decay, only a fragment of RCC panel would match the UHF radar cross-section and ballistic coefficients observed by the Space Surveillance network. Such an RCC panel fragment must be approximately 140 square inches or greater in area to meet the observed radar cross-section characteristics. Figure 3.5-1 shows RCC panel fragments from *Columbia*'s right wing that represent those meeting the observed characteristics of object 2003-003B.¹⁰

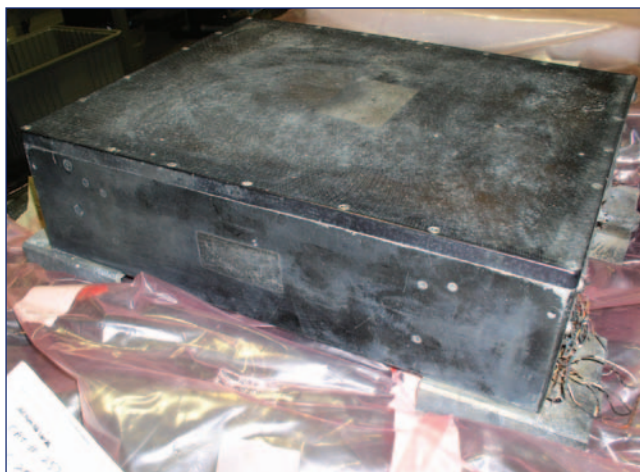
The Modular Auxiliary Data System is a supplemental instrumentation system that gathers Orbiter data for processing after the mission is completed. Inputs are almost exclusively physical sensor readings of temperatures, pressures, mechanical strains, accelerations, and vibrations. The Modular Auxiliary Data System usually records only the mission's first and last two hours (see Figure 3.6-1).

Figure 3.6-1. The Modular Auxiliary Data System recorder, found near Hemphill, Texas. While not designed to withstand impact damage, the recorder was in near-perfect condition when recovered on March 19, 2003.

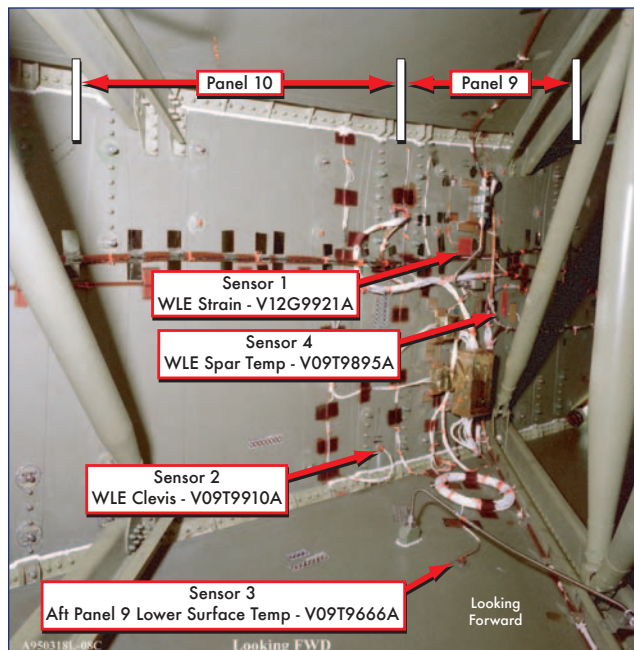
Figure 3.6-2. Location of sensors on the back of the left wing leading edge spar (vertical aluminum structure in picture). Also shown are the round truss tubes and ribs that provided the structural support for the mid-wing in this area.

or outside the wing leading edge spar near Reinforced Carbon-Carbon (RCC) panel 9-left, helped tell the story of what happened on the left wing of the Orbiter early in the re-entry. These four sensors were: strain gauge V12G9921A (Sensor 1), resistance temperature detector V09T9910A on the RCC clevis between panel 9 and 10 (Sensor 2), thermocouple V07T9666A, within a Thermal Protection System tile (Sensor 3), and resistance temperature detector V09T9895A (Sensor 4), located on the back side of the wing leading edge spar behind RCC panels 8 and 9 (see Figure 3.6-2).

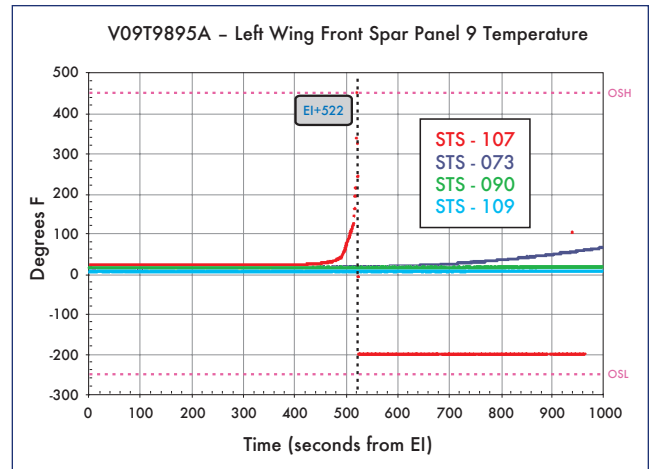
Figure 3.6-7. Sensor 4 also began reading significantly higher than previous flights before it fell off-scale low. The relatively late reaction of this sensor compared to Sensor 2, clearly indicated that superheated air started on the outside of the wing leading edge spar and then moved into the mid-wing after the spar was burned through. Note that immediately before the sensor (or the wire) fails, the temperature is at 450 degrees Fahrenheit and climbing rapidly. It was the only temperature sensor that showed this pattern.

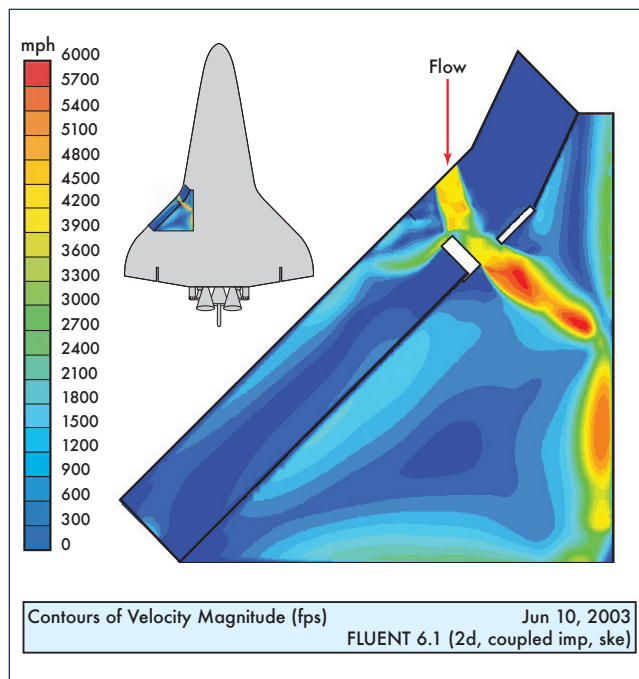
Later computational fluid dynamics analysis of the mid-wing area behind the spar showed that superheated air flowing into a breached RCC panel 8 and then interacting with the internal structure behind the RCC cavity (RCC ribs and spar insulation) would have continued through the wing leading edge spar as a jet, and would have easily allowed superheated air to traverse the 56.5 inches from the spar to the outside of the wheel well and destroy the cables (Figure 3.6-11). Controllers on the ground saw these first anomalies in the telemetry data at EI+613, when four hydraulic sensor cables that ran from the aft part of the left wing through the wiring bundles outside the wheel well failed.

Figure 3.6-11. The computational fluid dynamics analysis of the speed of the superheated air as it entered the breach in RCC panel 8 and then traveled through the wing leading edge spar. The darkest red color indicates speeds of over 4,000 miles per hour. Temperatures in this area likely exceeded 5,000 degrees Fahrenheit. The area of detail is looking down at the top of the left wing.

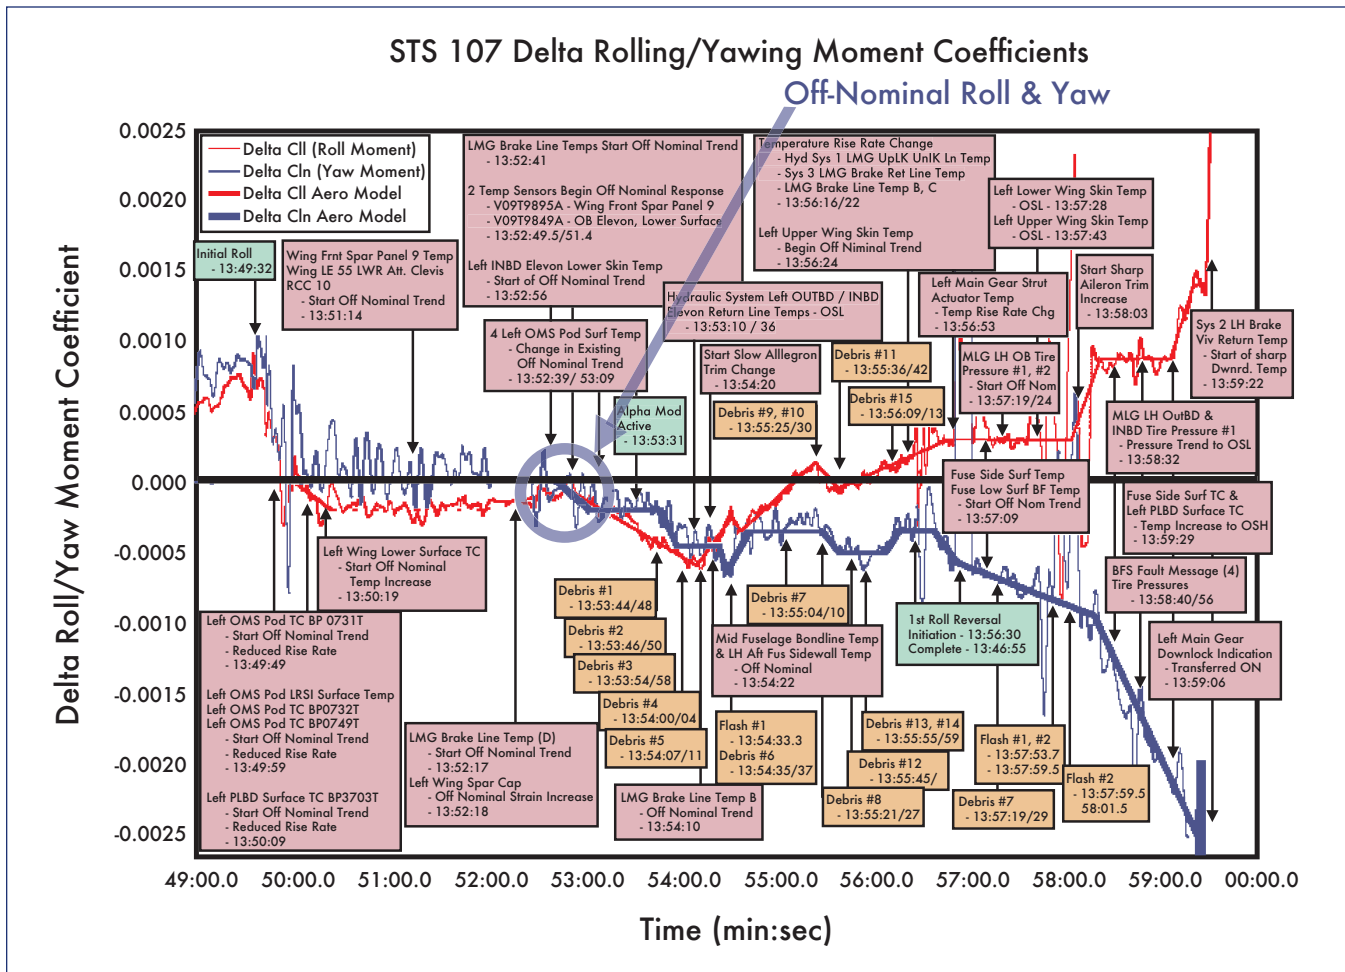
Aerodynamic roll and yaw forces began to differ from those on previous flights at about EI+500 (see Figure 3.6-12). Investigators used flight data to reconstruct the aerodynamic forces acting on the Orbiter. This reconstructed data was then compared to forces seen on other similar flights of *Columbia*

Figure 3.6-12. At approximately EI+500 seconds, the aerodynamic roll and yaw forces began to diverge from those observed on previous flights. The blue line shows the Orbiter's tendency to yaw while the red line shows its tendency to roll. Nominal values would parallel the solid black line. Above the black line, the direction of the force is to the right, while below the black line, the force is to the left.

and to the forces predicted for STS-107. In the early phase of flight, these abnormal aerodynamic forces indicated that *Columbia's* flight control system was reacting to a change in the external shape of the wing, which was caused by progressive RCC damage that caused a continuing decrease in lift and a continuing increase in drag on the left wing.

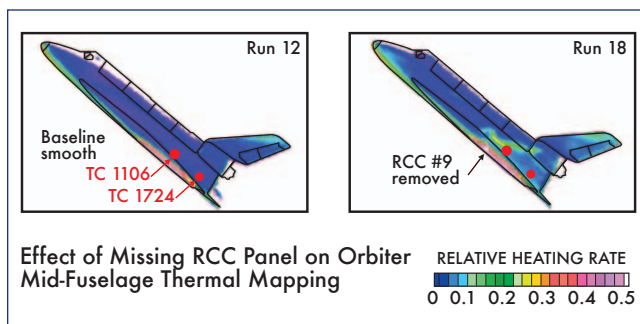
Figure 3.6-13. The effects of removing RCC panel 9 are shown in this figure. Note the brighter colors on the front of the OMS pod show increased heating, a phenomenon supported by both the OMS pod temperature sensors and the debris analysis.

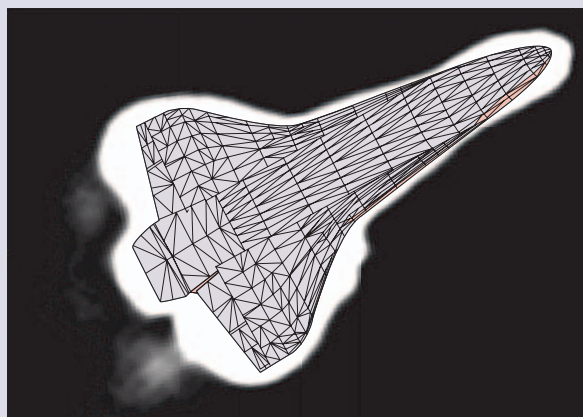
THE KIRTLAND IMAGE

As *Columbia* passed over Albuquerque, New Mexico, during re-entry (around EI+795), scientists at the Air Force Starfire Optical Range at Kirtland Air Force Base acquired images of the Orbiter. This imaging had not been officially assigned, and the photograph was taken using commercial equipment located at the site, not with the advanced Starfire adaptive-optics telescope.

The image shows an unusual condition on the left wing, a leading-edge disturbance that might indicate damage. Several analysts concluded that the distortion evident in the image likely came from the modification and interaction of shock waves due to the damaged leading edge. The overall appearance of the leading-edge damage at this point on the trajectory is consistent with the scenario.

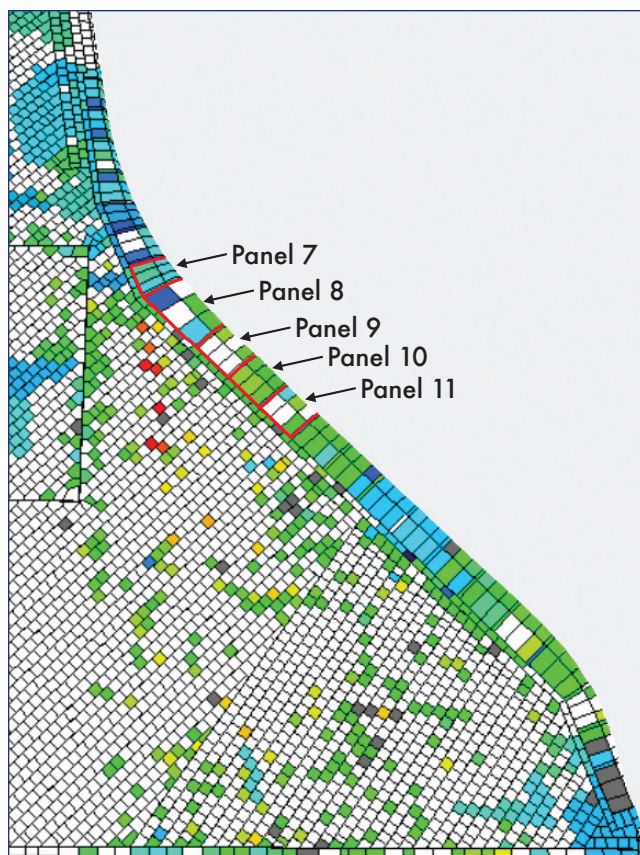
Figure 3.7-6. The tiles recovered farthest west all came from the area immediately behind left wing RCC panels 8 and 9. In the figure, each small box represents an individual tile on the lower surface of the left wing. The more red an individual tile appears, the farther west it was found.

An analysis of where tiles were found on the ground also yielded significant evidence of the breach location. Since most of the tiles are of similar size, weight, and shape, they would all have similar ballistic coefficients and would have behaved similarly after they separated from the Orbiter. By noting where each tile fell and then plotting its location on the Orbiter tile map, a distinctive pattern emerged. The tiles recovered farthest west all came from the area immediately behind the left wing RCC panel 8 and 9 (see Figure 3.7-6), which suggests that these tiles were released earlier than those from other areas of the left wing. While it is not conclusive evidence of a breach in this area, this pattern does suggest unique damage around RCC panels 8 and 9 that was not seen in other areas. Tiles from this area also showed evidence of a brown deposit that was not seen on tiles from any

other part of the Orbiter. Chemical analysis revealed it was an Inconel-based deposit that had come from inside the RCC cavity on the left wing (Inconel is found in wing leading edge attachment fittings). Since the streamlines from tiles with the brown deposit originate near left RCC panels 8 and 9, this brown deposit likely originated as an outflow of superheated air and molten metal from the panel 8 and 9 area.

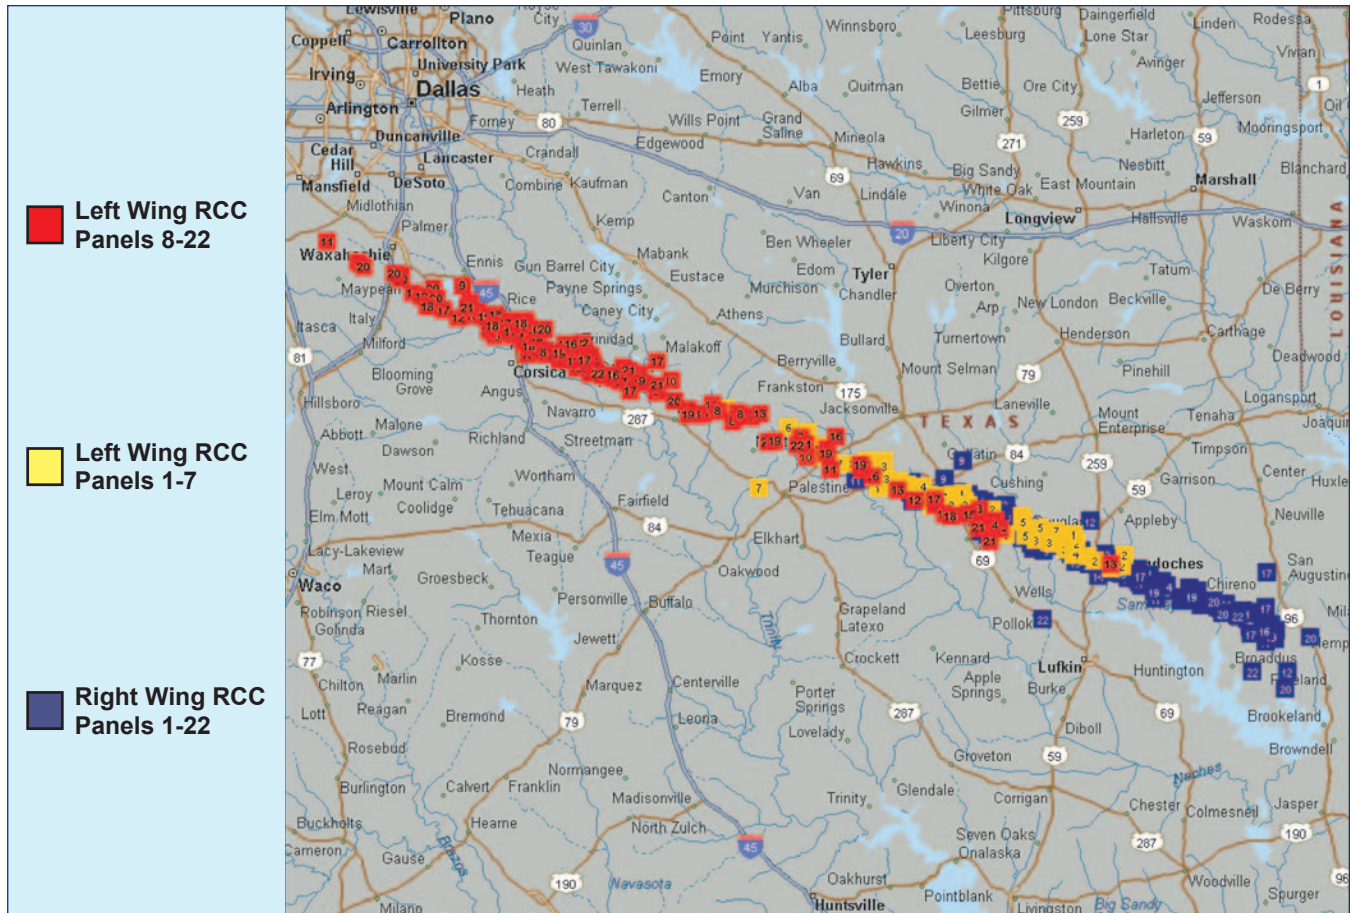
The location of debris on the ground also provided evidence of where the initial breach occurred. The location of every piece of recovered RCC was plotted on a map and labeled according to the panel the piece originally came from. Two distinct patterns were immediately evident. First, it was clear that pieces from left wing RCC panels 9 through 22 had fallen the farthest west, and that RCC from left wing panels 1 through 7 had fallen considerably farther east (see Figure 3.7-5). Second, pieces from left wing panel 8 were

Figure 3.7-5. The location of RCC panel debris from the left and right wings, shown where it was recovered from in East Texas. The debris pattern suggested that the left wing failed before the right wing, most likely near left RCC panels 8 and 9.

found throughout the debris field, which suggested that the left wing likely failed in the vicinity of RCC panel 8. The early loss of the left wing from RCC panel 9 and outboard caused the RCC from that area to be deposited well west of the RCC from the inboard part of the wing. Since panels 1 through 7 were so much farther to the east, investigators concluded that RCC panels 1 through 7 had stayed with the Orbiter longer than had panels 8 through 22.

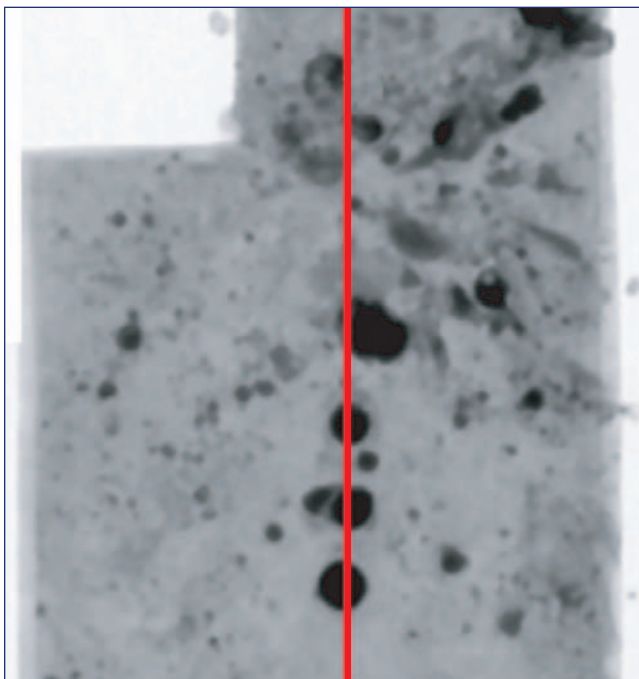
The X-ray analysis of left wing RCC panel 8 (see Figure 3.7-7) showed a bottom-to-top pattern of slag deposits. In some areas, small spheroids of heavy metal were aligned vertically on the recovered pieces, which indicated a superheated airflow from the bottom of the panel toward the top in the area of RCC panel 8-left. These deposits were later determined by chemical analysis to be Inconel 718, probably from the wing leading edge attachment fittings on the spanner beams on RCC panels 8 and 9. Computational fluid dynamics modeling of the flow behind panel 8 indicated that the molten deposits would be laid down in this manner.

Figure 3.7-7. X-ray analysis of RCC panel 8-left showed a bottom-to-top pattern of slag deposits.

The layered deposits on panel 8 were also markedly different from those on all other left- and right-wing panels. There was much more material deposited on RCC panel 8-left. These deposits had a much rougher overall structure, including rivulets of Cerachrome slag deposited directly on the RCC. This indicated that Cerachrome, the insulation that protects the wing leading edge spar, was one of the first materials to succumb to the superheated air entering through the breach in RCC panel 8-left. Because the melting temperature of Cerachrome is greater than 3,200 degrees Fahrenheit, analysis indicated that materials in this area were exposed to extremely

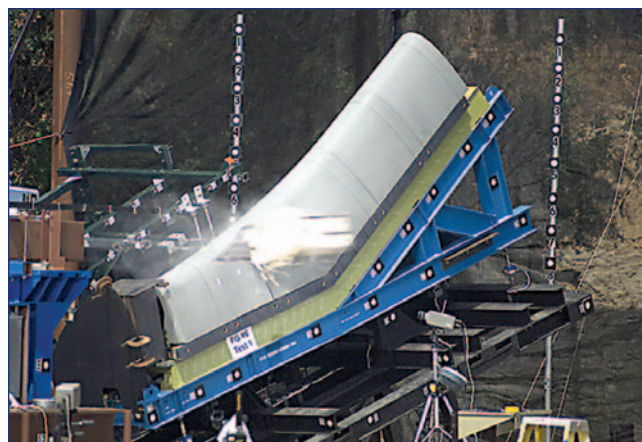
Five engineering tests on fiberglass panels (see Figure 3.8-5) established the test parameters of the impact tests on RCC panels. Details of the fiberglass tests are in Appendix D.12.

Figure 3.8-5. A typical foam strike leaves impact streaks, and the foam projectile breaks into shards and larger pieces. Here the foam is striking Panel 6 on a fiberglass test article.

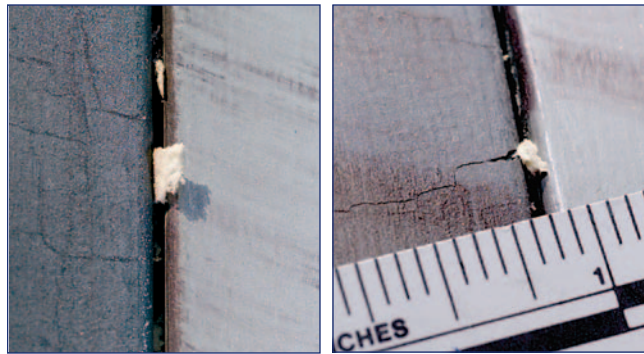
Figure 3.8-8. Two views of foam lodged into the slit during tests.

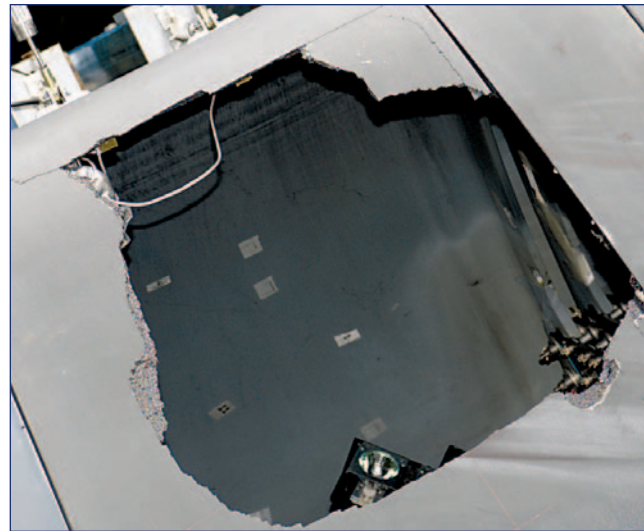
The second impact test of RCC material used panel 8 from *Atlantis*, which had flown 26 missions. Based on forensic evidence, sensor data, and aerothermal studies, panel 8 was considered the most likely point of the foam debris impact on *Columbia*.

Figure 3.8-9. The large impact hole in Panel 8 from the final test.

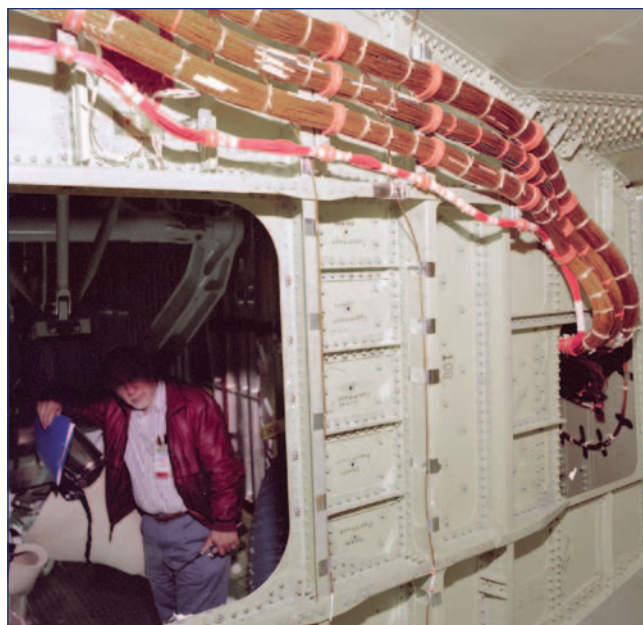
Figure 4.2-3. Typical wiring bundle inside Orbiter wing.

A typical wiring bundle is shown in Figure 4.2-3. Wiring nonconformances are corrected by rerouting, reclamping, or installing additional insulation such as convoluted tubing, insulating tape, insulating sheets, heat shrink sleeving, and abrasion pads (see Figure 4.2-4). Testing has shown that wiring bundles usually stop arc tracking when wires are physically separated from one another. Further testing under conditions simulating the Shuttle's wiring environment demonstrated that arc tracking does not progress beyond six inches. Based on these results, Boeing recommended that NASA separate all critical paths from larger wire bundles and individually protect them for a minimum of six inches beyond their separation points.⁴ This recommendation is being adopted through modifications performed during scheduled Orbiter Major Modifications. For example, analysis of telemetered data from 14 of *Columbia's* left wing sensors (hydraulic line/wing skin/wheel temperatures, tire pressures, and landing gear downlock position indication) provided failure signatures supporting the scenario of left-wing thermal intrusion, as opposed to a catastrophic failure (extensive arc tracking) of Kapton wiring. Actual NASA testing in the months following the accident, during which wiring bundles were subjected to intense heat (ovens, blowtorch, and arc jet), verified the failure signature analyses. Finally, extensive testing and analysis in years prior to STS-107 showed that, with the low currents and low voltages associated with the Orbiter's instrumentation system (such as those in the left wing), the probability of arc tracking is commensurately low.

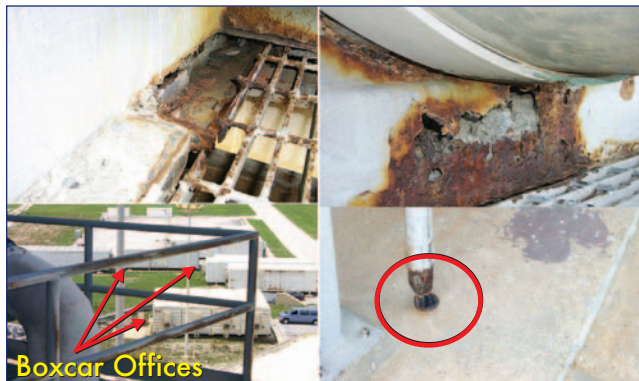
Board investigators have identified deteriorating infrastructure associated with the launch pads, Vehicle Assembly Building, and the crawler transporter. Figures 5.5-5 and 5.5-6 depict some of this deterioration. For example, NASA has installed nets, and even an entire sub-roof, inside the Vehicle Assembly Building to prevent concrete from the building’s ceiling from hitting the Orbiter and Shuttle stack. In addition, the corrosion-control challenge results in zinc primer

on certain launch pad areas being exposed to the elements. When rain falls on these areas, it carries away zinc, runs onto the leading edge of the Orbiter’s wings, and causes pinholes in the Reinforced Carbon-Carbon panels (see Chapter 3).

Figure 5.5-5 and 5.5-6. Examples of the seriously deteriorating infrastructure used to support the Space Shuttle Program. At left is Launch Complex 39A, and at right is the Vehicle Assembly building, both at the Kennedy Space Center.

In Fiscal Year 2002, Congress added \$25 million to NASA’s budget for Vehicle Assembly Building repairs. NASA has reallocated limited funds from the Shuttle budget to pressing infrastructure repairs, and intends to take an integrated look at infrastructure as part of its new Shuttle Service Life Extension Program. Nonetheless, like Space Shuttle upgrades, infrastructure revitalization has been mired by the uncertainty surrounding the Shuttle Program’s lifetime. Considering that the Shuttle will likely be flying for many years to come, NASA, the White House, and Congress alike now face the specter of having to deal with years of infrastructure neglect.

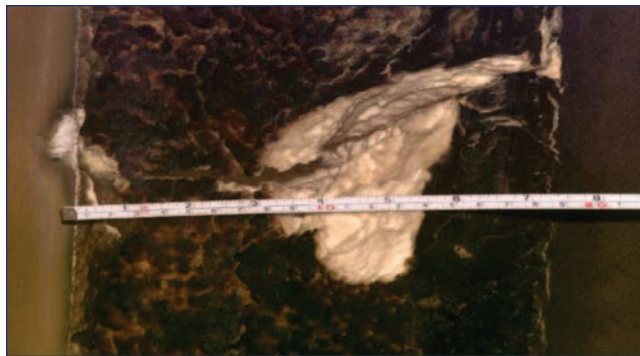
The sixth and final bipod ramp event before STS-107 occurred during STS-112 on October 7, 2002 (see Figure 6.1-3). At 33 seconds after launch, when *Atlantis* was at 12,500 feet and traveling at Mach 0.75, ground cameras observed an object traveling from the External Tank that subsequently impacted the Solid Rocket Booster/External Tank Attachment ring (see Figure 6.1-4). After impact, the debris broke into multiple pieces that fell along the Solid Rocket Booster exhaust plume.¹⁵ Post-mission inspection of the Solid Rocket Booster confirmed damage to foam on the forward face of the External Tank Attachment ring. The impact was approximately 4 inches wide and 3 inches deep. Post-External Tank separation photography by the crew showed that a 4- by 5- by 12-inch (240 cubic-inch) corner section of the left bipod ramp was missing, which exposed the super lightweight ablator coating on the bipod housing. This missing chunk of foam was believed to be the debris that impacted the External Tank Attachment ring during ascent. The post-launch review of photos and video identified these debris events, but the Mission Evaluation Room logs and Mission Management Team minutes do not reflect any discussions of them.

Figure 6.1-4. On STS-112, the foam impacted the External Tank Attach ring on the Solid Rocket Booster, causing this tear in the insulation on the ring.

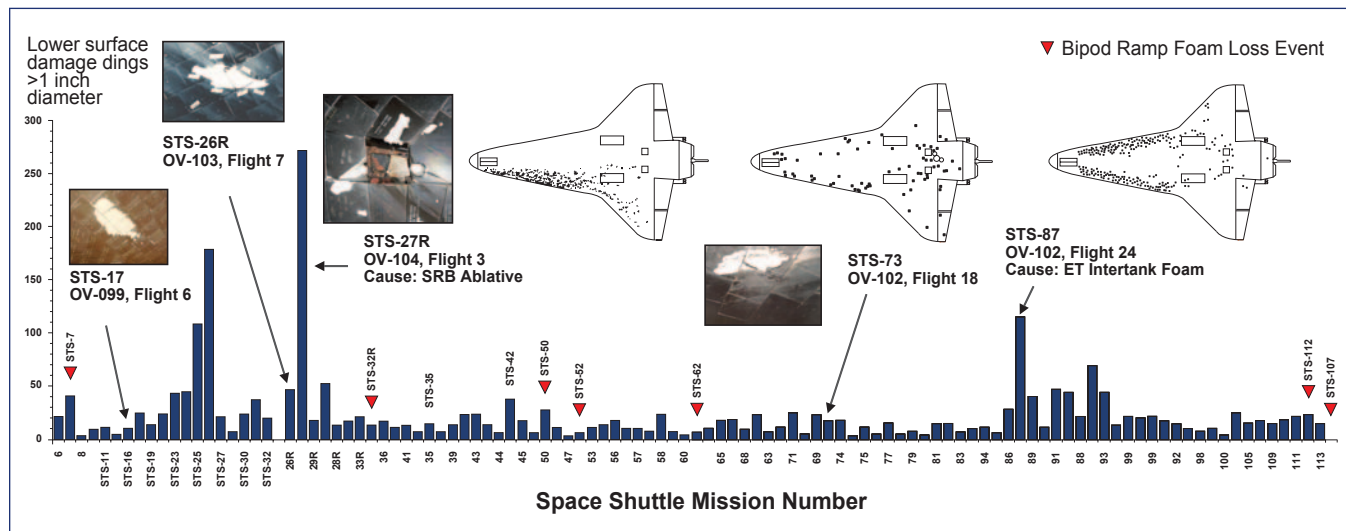
Figure 6.1-6. This chart shows the number of dings greater than one inch in diameter on the lower surface of the Orbiter after each mission from STS-6 through STS-113. Flights where the bipod ramp foam is known to have come off are marked with a red triangle.

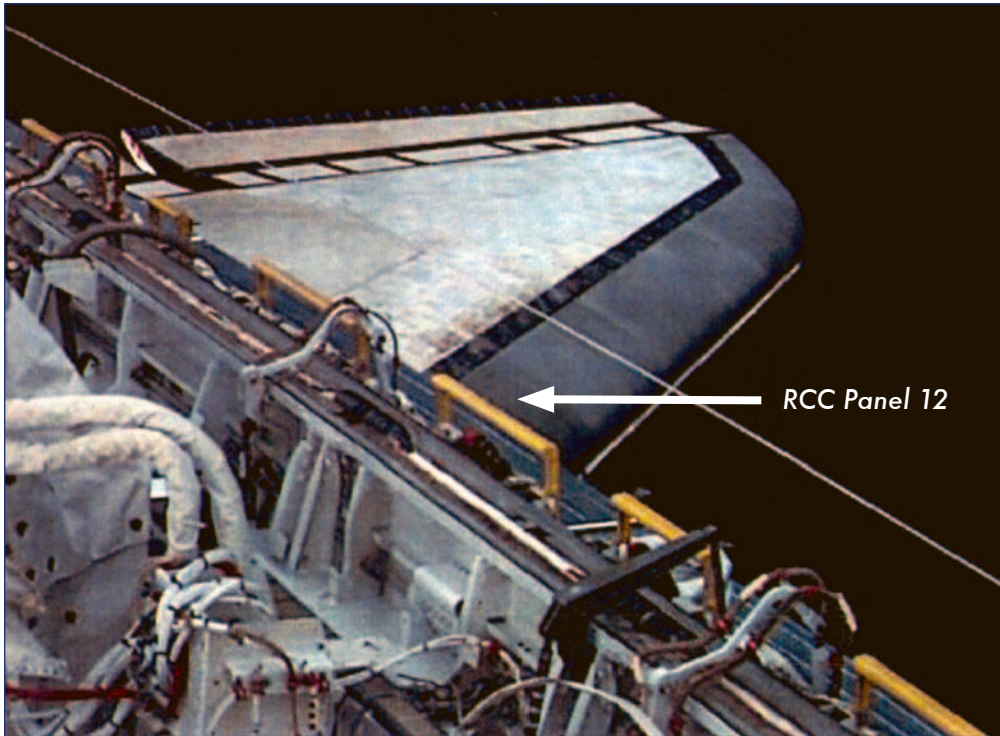
This photo from the aft flight deck window of an Orbiter shows that RCC panels 1 – 11 are not visible from inside the Orbiter. Since Columbia did not have a manipulator arm for STS-107, it would have been necessary for an astronaut to take a spacewalk to visibly inspect the inboard leading edge of the wing.

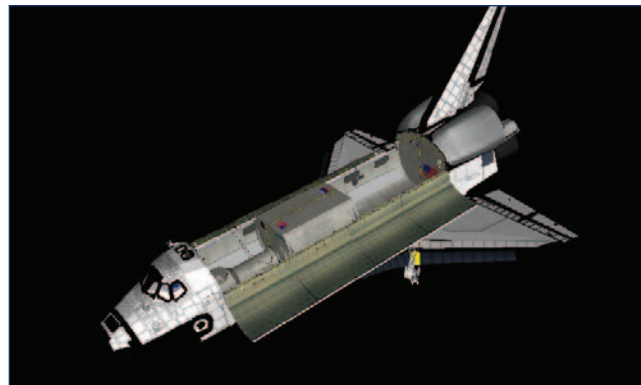
Figure 6.4-1. The speculative repair option would have sent astronauts hanging over the payload bay door to reach the left wing RCC panels using a ladder scavenged from the crew module.

The repair option (see Figure 6.4-1), while logistically viable using existing materials onboard *Columbia*, relied on so many uncertainties that NASA rated this option "high risk." To complete a repair, the crew would perform a spacewalk to fill an assumed 6-inch hole in an RCC panel with heavy metal tools, small pieces of titanium, or other metal scavenged from the crew cabin. These heavy metals, which would help protect the wing structure, would be held in place during

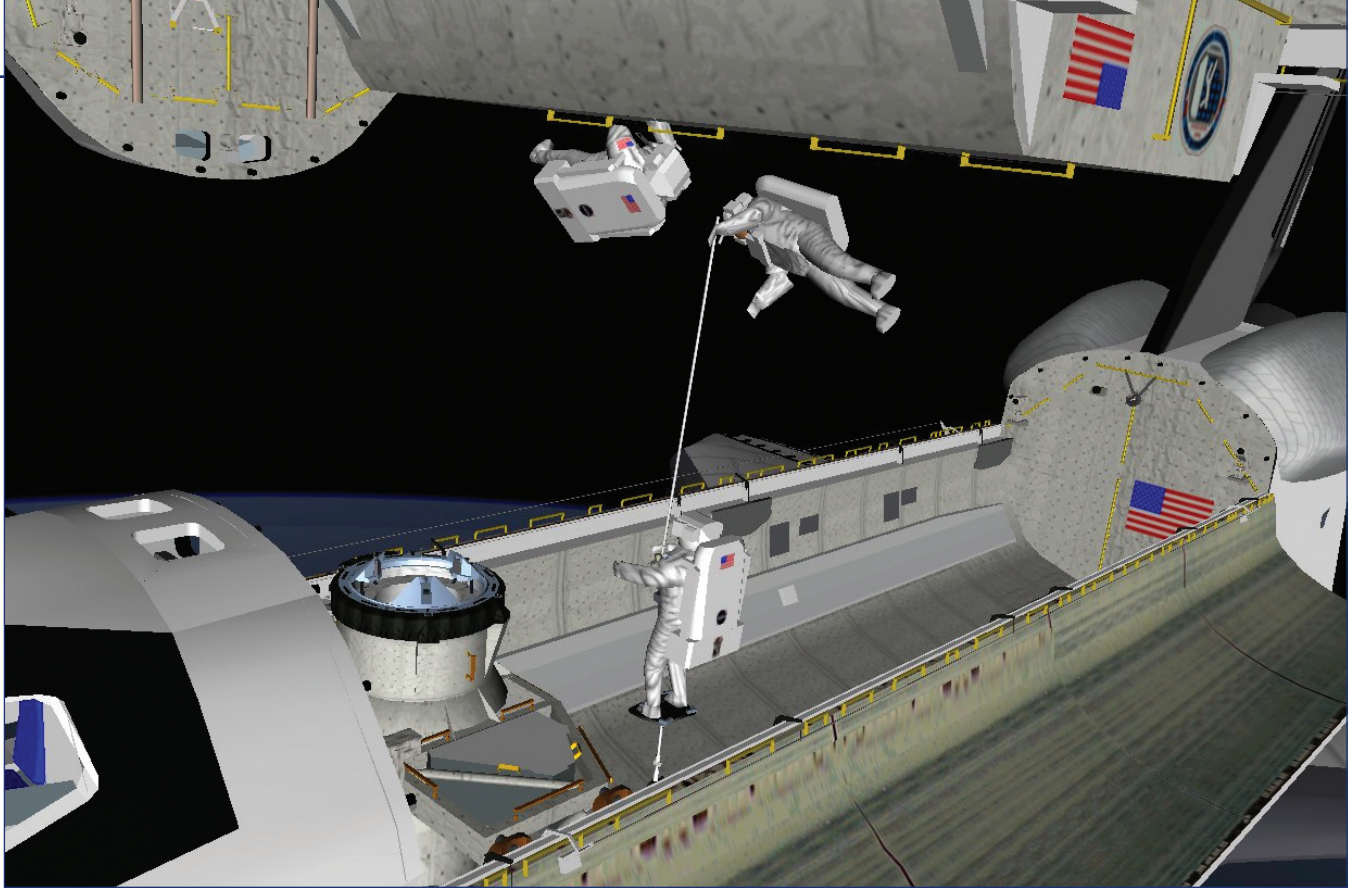
Figure 6.4-2. The rescue option had Atlantis (lower vehicle) rendezvousing with Columbia and the STS-107 crew transferring via ropes. Note that the payload bay of Atlantis is empty except for the external airlock/docking adapter.

er, pilot, and two astronauts trained for spacewalks. In January, seven commanders, seven pilots, and nine spacewalk-trained astronauts were available. During the rendezvous on *Atlantis*'s first day in orbit, the two Orbiters would maneuver to face each other with their payload bay doors open (see Figure 6.4-2). Suited *Columbia* crew members would then be transferred to *Atlantis* via spacewalks. *Atlantis* would return with four crew members on the flight deck and seven in the mid-deck. Mission Control would then configure *Columbia* for a de-orbit burn that would ditch the Orbiter in the Pacific Ocean, or would have the *Columbia* crew take it to a higher orbit for a possible subsequent repair mission if more thorough repairs could be developed.

This rescue was considered challenging but feasible. To succeed, it required problem-free processing of *Atlantis* and a flawless launch countdown. If Program managers had understood the threat that the bipod foam strike posed and were able to unequivocally determine before Flight Day Seven that there was potentially catastrophic damage to the left wing, these repair and rescue plans would most likely have been developed, and a rescue would have been conceivable. For a detailed discussion of the rescue and repair options, see Appendix D.13.
